Minerals Inspection Report

Report Date: 03/24/2015

Mine Name: Pelican Point	Permit Number: M/49/0011	Mine Status: Active
Operator Name: Geneva Rock Products	Inspection Date: 3/24/2015	Permit Fees: 1000
Inspector(s): A. Abate, P. Baker	Inspection Time: 12 PM	Bond Amount: \$1,092,000
Attendee(s): B. Sumsion	Weather: Clear, Windy 50s	Bond Escalation:
Inspection Purpose: Routine Inspection		Prior Inspection: 01/01/2005

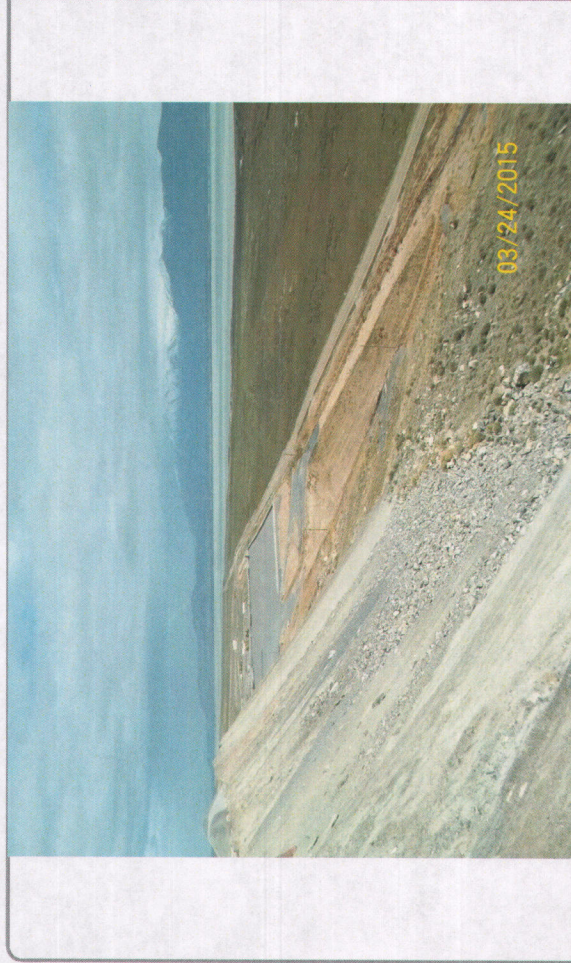
Outslopes of quarry operation were at angle of repose with no vegetation growing on them.

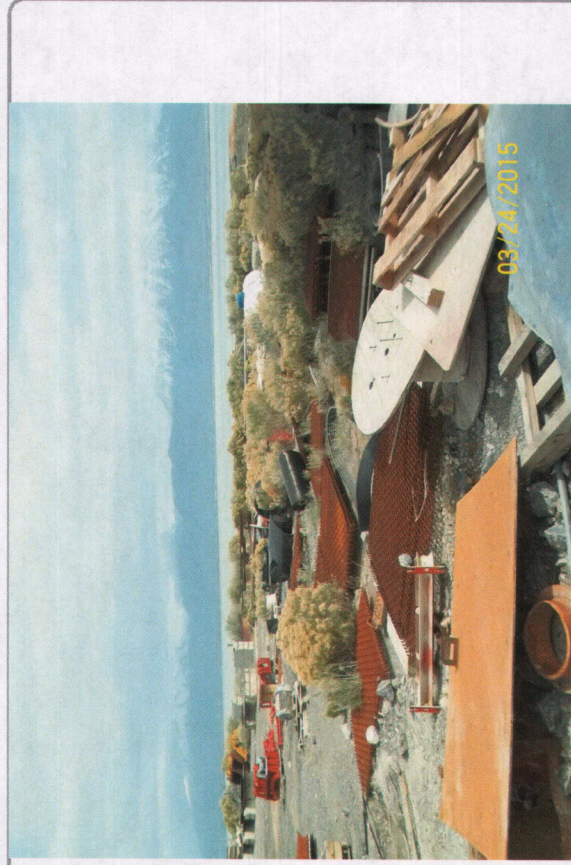
4. <i>Deleterious Material</i>	<input checked="" type="checkbox"/>	<input type="checkbox"/>
The maintenance buildings and associated bone yard had lots of scrap metal, old equipment and some empty 55-gallon open drums. The operator was asked to remove the drums and any other refuse that the operation was not using.

Bone yard had a large amount of rusty scrap metal and other refuse including two 55-gallon drums.

The bond was adequate for this amount of disturbance. The site itself should be tidied up by cleaning up some of the refuse in the bone yard and conducting some weed removal actions.

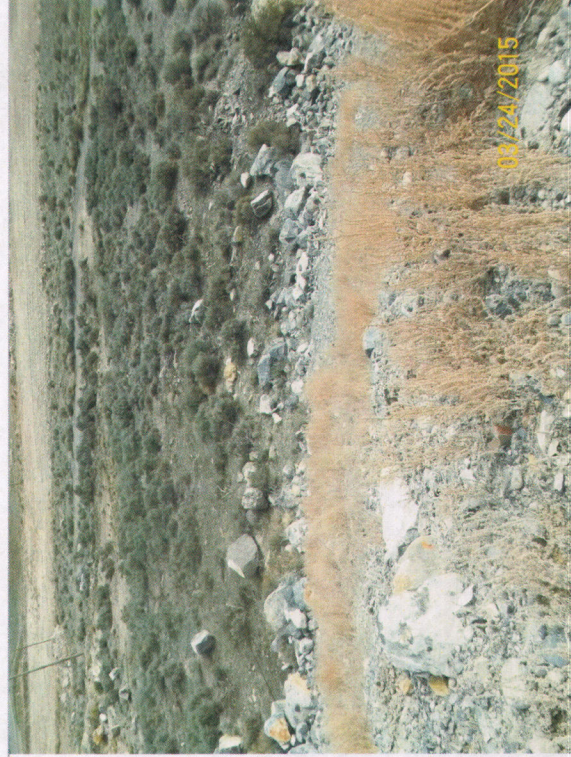
Some of the outslopes had halogeten weeds growing on them

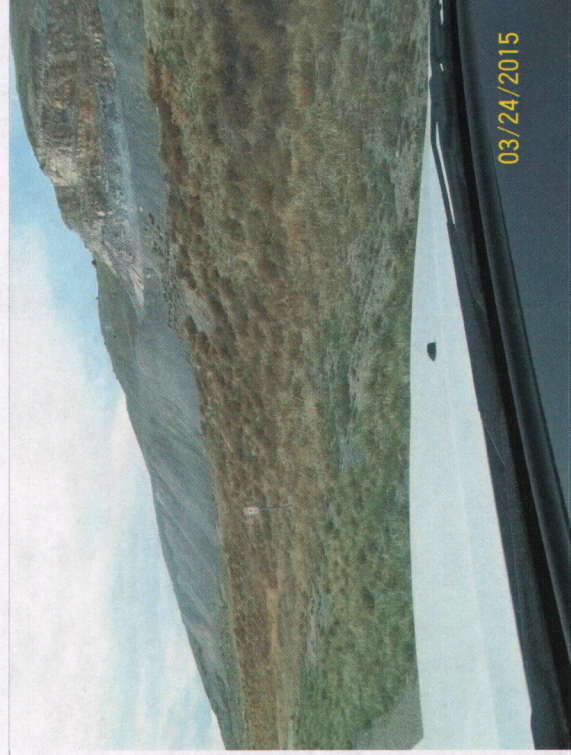
The outslopes at the base of the poured staging area were seeded with Russian thistle and some halogeten. Some noxious Scotch thistle were present on the slopes and should be remo
